Town of Arlington, Massachusetts

PART A – Executive Summary Self- Evaluation and Transition Plan

November 2019

Part A – Executive Summary

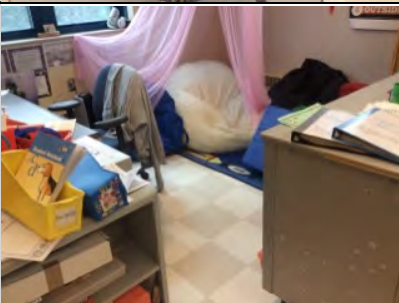
Route < 36" wide	16"	Rearrange furniture so that a clear width of 36" min. is maintained at the accessible route to the book area.	1	Labor	\$0
27	1st Grade Classroom/ Resource Room	1	117	Interior Access Route	N/A

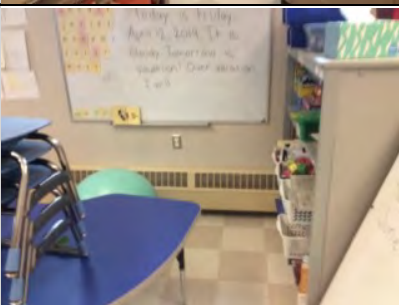
Accessible route not provided	-	Rearrange furniture so that a clear width of 36" min. is maintained at the accessible route to the white board.	1	Labor	\$0

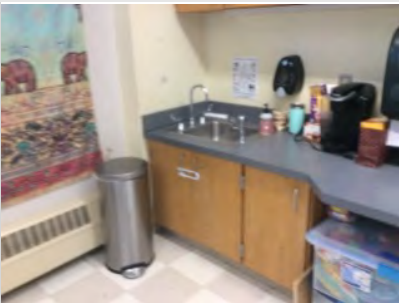
Additional Access												
28	1st Grade Classroom/ Resource Room	1	117	Sinks for Children's Use	Classroom

Knee or toe clearance not provided Clear floor space not provided	-	Provide at least one sink with 25" knee and toe clearance positioned for a forward approach. Remove trash can to provide a 30" x 48" clear floor space at the sink.	1	843	\$843
Approach and Entrance												
29	Kindergarten 119	1	119	Emergency Exit	N/A

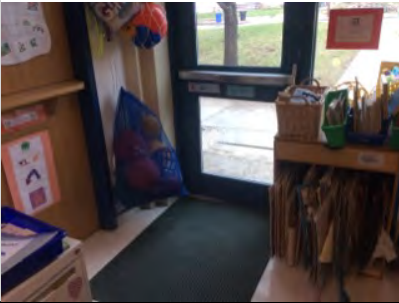
International Symbol of Acc. not provided Tactile exit sign not provided Mat not securely attached	- - -	Provide an illuminated sign with the International Symbol of Accessibility. Provide a tactile exit sign with raised characters and braille are provided at exit doors. Mount signs between 48" - 60" above the finished floor on the latch side of the door. Secure the mat.	1	232	\$232

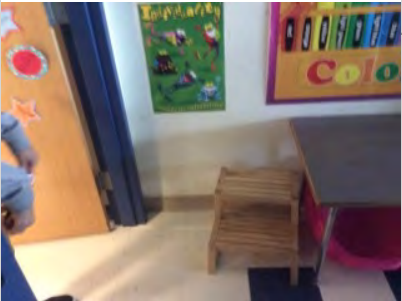
Maneuvering clearance(s) not provided	-	Relocate furniture allow for maneuvering clearance at the door. (48" clear recommended in front of the door).	1	Labor	\$0
31	Kindergarten Classroom	1	119	Interior Access Route	N/A

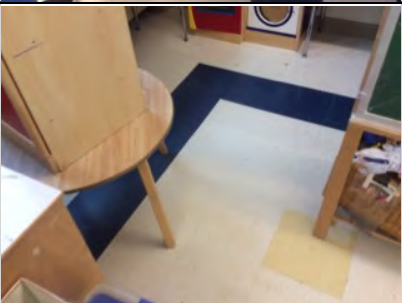
Route < 36" wide	22"	Rearrange furniture so that a clear width of 36" min. is maintained at the accessible route to the play area.	1	Labor	\$0
Approach and Entrance												
32	Kindergarten 120	1	120	Emergency Exit	N/A

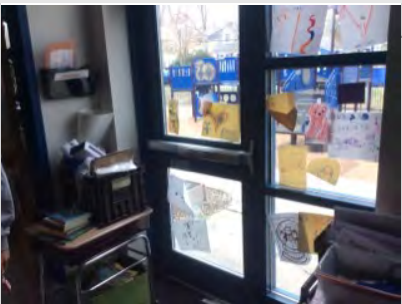
International Symbol of Acc. not provided Tactile exit sign not provided Mat not securely attached	<ul style="list-style-type: none">---	Provide an illuminated sign with the International Symbol of Accessibility. Provide a tactile exit sign with raised characters and braille are provided at exit doors. Mount signs between 48" - 60" above the finished floor on the latch side of the door. Secure the mat.	1	232	\$232

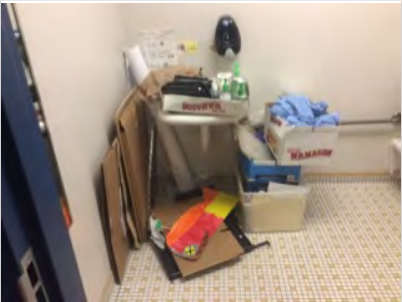
Toilet Rooms for Children												
33	Kindergarten 120 Toilet Room	1	120	Lavatory	N/A

Toe or knee clearances not provided		Provide at least one lavatory with 25" min. knee clearance positioned for a forward approach. Relocate stored items.	1	Labor	\$0
34	Kindergarten 120 Toilet Room	1	120	Single-User Toilet	N/A

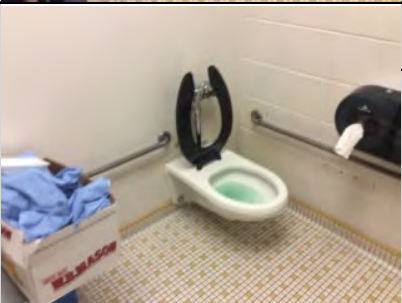
Toilet seat < 11" or > 12" high (Pre-K) Non-compliant toilet paper dispenser	15" -	Install a toilet with a seat between 11"- 12" high above the finished floor. Replace toilet paper dispenser with one that allows continuous paper flow and locate this dispenser under the grab bar.	1	1436	\$1436

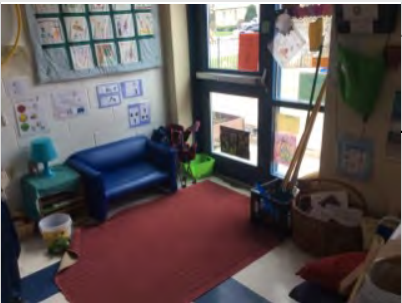
International Symbol of Acc. not provided Tactile exit sign not provided Mat not securely attached Maneuvering clearance(s) not provided	<ul style="list-style-type: none">----	Provide an illuminated sign with the International Symbol of Accessibility. Provide a tactile exit sign with raised characters and braille are provided at exit doors. Mount signs between 48" - 60" above the finish floor on the latch side of the door. Remove the furniture to provide maneuvering clearance at the door. Secure the mat.	1	232	\$232

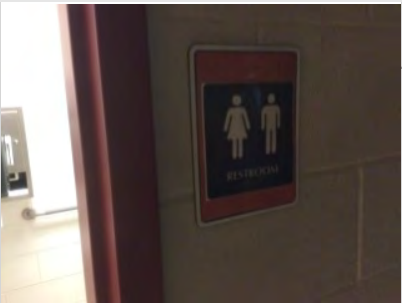
Access to Goods and Services												
37	All-Gender Second Floor Toilet Room	2		Signage	Designation

Raised characters not provided Braille not provided International Symbol of Acc. not compliant	<ul style="list-style-type: none">---	After toilet room is made accessible, replace paper sign with a sign containing the International Symbol of Accessibility, as well as raised characters duplicated in braille.	2	116	\$232
Toilet & Bathing Rooms												
38	All-Gender Second Floor Toilet Room	2		Single-User Toilet	N/A

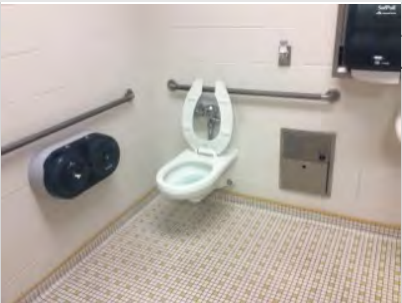
Centerline < or > 18" (MAAB) Toilet paper dispenser is not compliant	19" -	Relocate toilet so that the centerline is 18" from the side wall. Replace toilet paper dispenser with one that allows continuous paper flow.	1	1767	\$1767

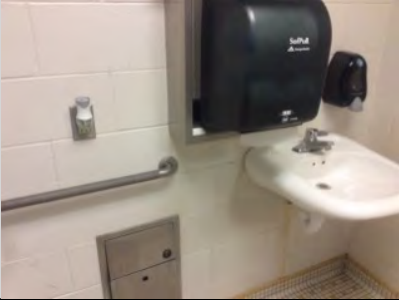
Dispenser acts as a protruding object	-	Relocate dispenser out of the circulation path and/or provide a low-profile dispenser.	1	353	\$353
Toilet Rooms for Children												
40	Boys' Second Floor Toilet Room	2		Lavatory	N/A

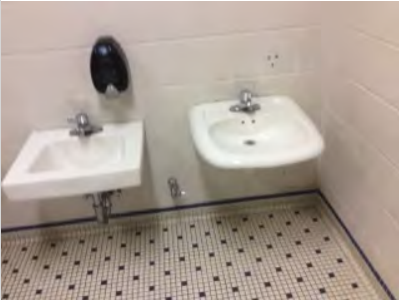
Exposed plumbing underneath	-	Insulate or otherwise configure pipes to prevent contact, for at least one lavatory.	1	46	\$46
41	Boys' Second Floor Toilet Room	2		Urinal	N/A

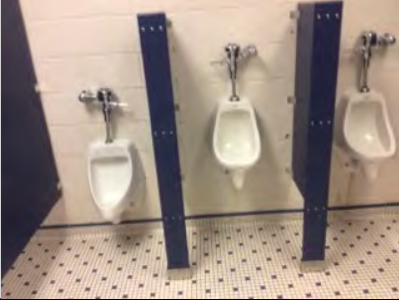
Rim > 15" high (MAAB)	16"	Provide at least one urinal with the rim no higher than 15" above the finished floor.	1	1624	\$1624
42	Boys' Second Floor Toilet Room	2		Toilet Compartment	Accessible Compartment

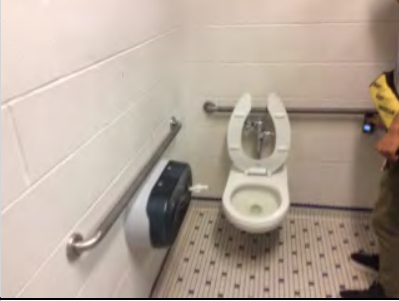
Side or rear grab bar < 20" or > 25" high (Ages 5 - 8) Non-compliant toilet paper dispenser	30" -	Relocate grab bars to 20"- 25" above the floor. Replace toilet paper dispenser with one that allows continuous paper flow.	1	1059	\$1059

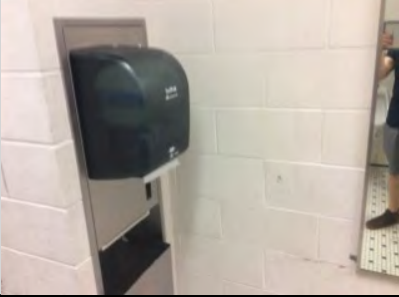
43	Boys' Second Floor Toilet Room	2		Dispensers	Paper Towel Dispenser

Dispenser acts as a protruding object	-	Relocate dispenser out of the circulation path or provide a low-profile dispenser.	1	353	\$353

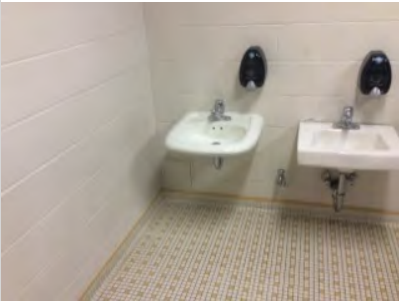
Exposed plumbing underneath	-	Insulate or otherwise configure pipes to prevent contact, for at least one lavatory.	1	46	\$46
45	Girls' Second Floor Toilet Room	2		Dispensers	Paper Towel Dispenser

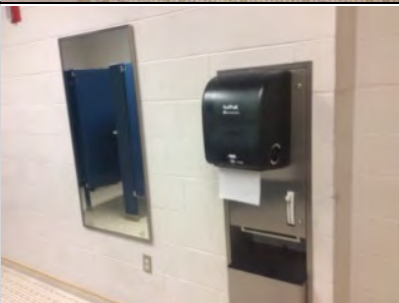
Dispenser acts as a protruding object	-	Relocate dispenser out of the circulation path or provide a low-profile dispenser.	1	353	\$353
46	Girls' Second Floor Toilet Room	2		Toilet Compartment	Accessible Compartment

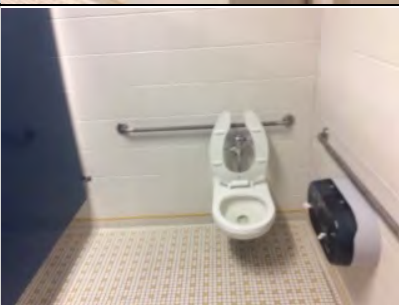
Side or rear grab bar < 25" or > 27" high (Ages 9 - 12) Centerline < 15" or > 18" (Ages 9 - 12) Non-compliant toilet paper dispenser	30" 19" -	Relocate grab bars to 25"- 27" above the floor. Relocate the toilet so that the centerline is between 15" and 18" from the side wall. Replace toilet paper dispenser with one that allows continuous paper flow.	1	1895	\$1895

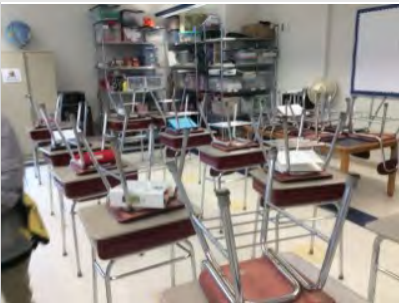
Access to Goods and Services												
47	Math Room	2	201	Dining or Work Surfaces	Work Surface

At least one or 5% accessible tables not provided	-	Provide at least one (1) accessible desk with 24" min. knee clearance and 30" min. clear width. Ensure accessible work surfaces are well integrated with class seating plans.	1	350	\$350
48	Math Room	2	201	Interior Access Route	N/A

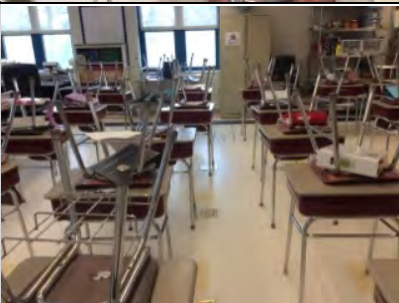
Route < 36" wide	24"	Reconfigure room to ensure that there is a clear width of 36" min. between desks.	1	Labor	\$0

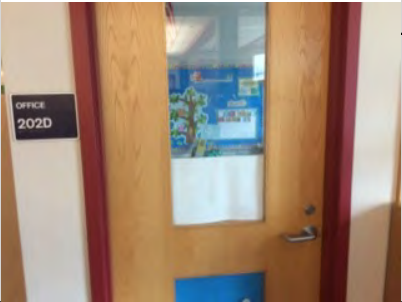
Sign not located on the latch side of the door	-	Locate sign at permanent rooms alongside the door on the latch side.	1	Labor	\$0
50	Library Office	2	202D	Operable Parts	Other

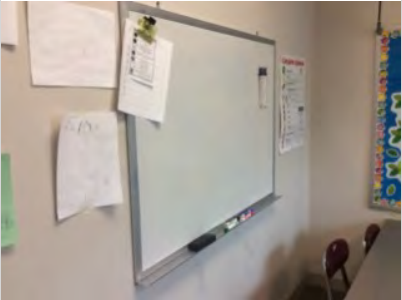
Clear floor space is not provided	-	Provide a 30" min. by 48" min. clear floor space at the white board.	1	Labor	\$0
Access to Goods and Services												
51	Science Room	2	204	Interior Access Route	N/A

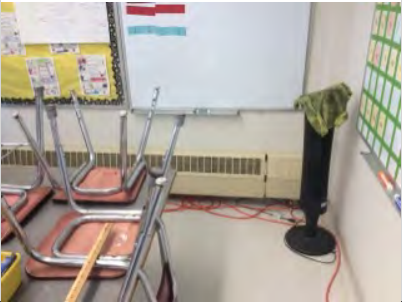
Surface not stable, firm, and slip-resistant	-	Relocate the cables.	1	Labor	\$0
Additional Access												
52	Science Room	2	204	Sinks for Children's Use	Classroom

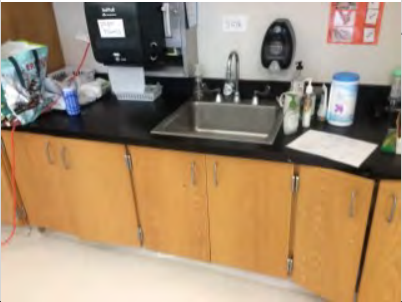
Knee or toe clearance not provided	-	Provide at least one sink with 25" knee and toe clearance positioned for a forward approach.	1	843	\$843

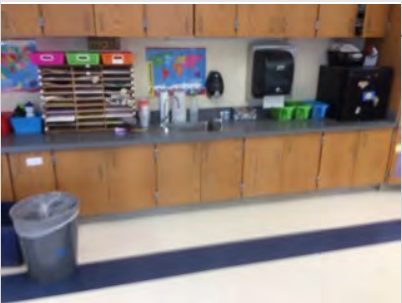
Knee or toe clearance not provided	-	Provide at least one sink with 25" knee and toe clearance positioned for a forward approach.	1	843	\$843
Additional Access												
55	3rd Grade Classroom	2	219	Sinks for Children's Use	Classroom

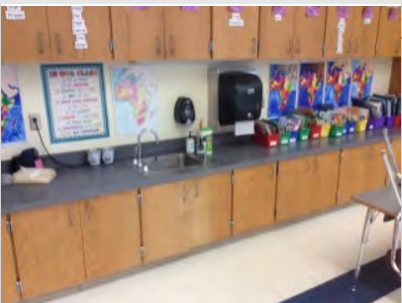
Knee or toe clearance not provided	-	Provide at least one sink with 25" knee and toe clearance positioned for a forward approach.	1	843	\$843

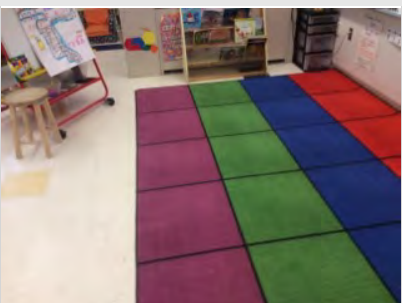
Access to Goods and Services												
56	3rd Grade Classroom, Classroom 220, 4th Grade Classroom, Library, 3rd Grade Classroom	2	219 220 205 202	Interior Access Route	N/A

Surface not stable, firm, and slip-resistant	-	Secure the mats.	6	Labor	\$0

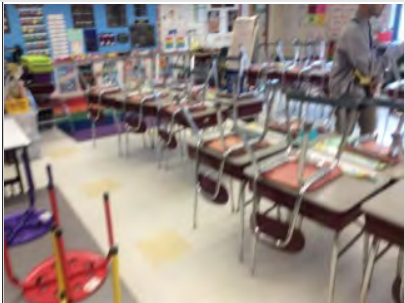
At least one or 5% accessible tables not provided	-	Provide at least one (1) accessible table with 24" min. knee clearance and 30" min. clear width. Ensure accessible work surfaces are well integrated with class seating plans.	1	350	\$350
Additional Access												
59	Classroom 220	2	220	Sinks for Children's Use	Classroom

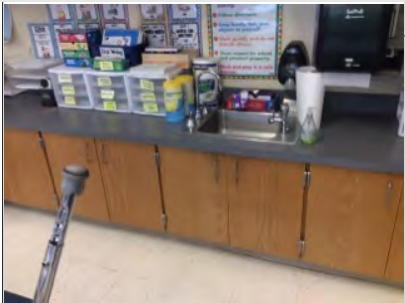
Knee or toe clearance not provided	-	Provide at least one sink with 25" knee and toe clearance positioned for a forward approach.	1	843	\$843

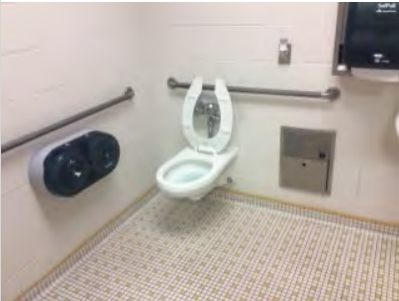
ID	Location	Floor	Room	Element	Type	Photo	Issues	Current Measure	Recommendations	Quantity	Price	Cost Estimation
Toilet & Bathing Rooms												
61	All-Gender Third Floor Toilet Room	3		Single-User Toilet	N/A

Centerline < or > 18" (MAAB) Toilet paper dispenser is not compliant	19" -	Relocate toilet so that the centerline is 18" from the side wall. Replace toilet paper dispenser with one that allows continuous paper flow.	1	1767	\$1767
62	All-Gender Third Floor Toilet Room	3		Dispensers	Paper Towel Dispenser

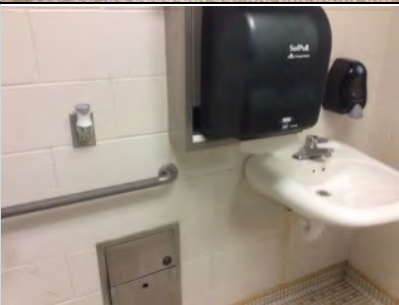
Dispenser acts as a protruding object	-	Relocate dispenser out of the circulation path and/or provide a low-profile dispenser.	1	353	\$353
Toilet Rooms for Children												
63	Boys' Third Floor Toilet Room	3		Urinal	N/A

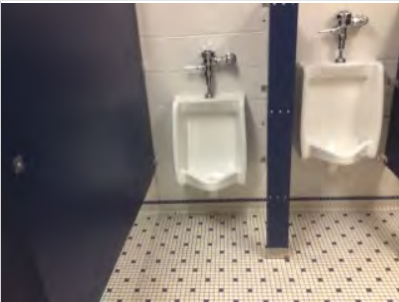
Rim > 15" high (MAAB)	16"	Provide at least one urinal with the rim no higher than 15" above the finished floor.	1	1624	\$1624
64	Boys' Third Floor Toilet Room	3		Toilet Compartment	Accessible Compartment

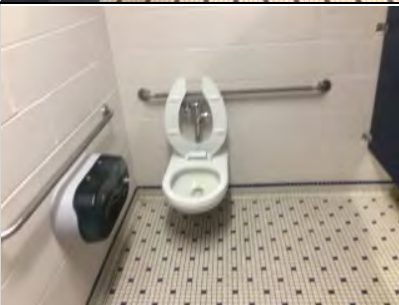
Side or rear grab bar < 25" or > 27" high (Ages 9 - 12) Centerline < 15" or > 18" (Ages 9 - 12) Non-compliant toilet paper dispenser	30" 19" -	Relocate grab bars to 25"- 27" above the floor. Relocate toilet so that the centerline is between 15" and 18" from the side wall. Replace toilet paper dispenser with one that allows continuous paper flow.	1	1895	\$1895

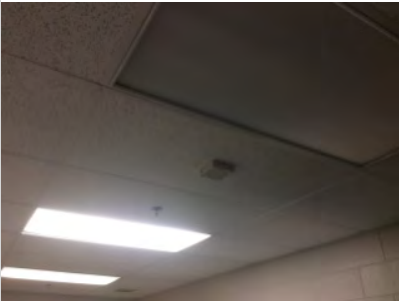
Best Practice												
65	Girls' Third Floor Toilet Room	3			Lighting

Best Practice: Recommend ensuring that lighting fixtures are in adequate working condition.	1	-	\$0

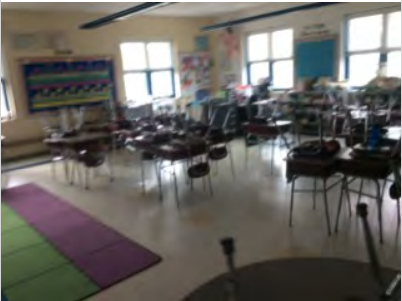
ID	Location	Floor	Room	Element	Type	Photo	Issues	Current Measure	Recommendations	Quantity	Price	Cost Estimation
Access to Goods and Services												
66	3rd Grade Classroom (Alternative)	3	301	Dining or Work Surfaces	Work Surface

At least one or 5% accessible tables not provided	-	Provide at least one (1) accessible desk with 24" min. knee clearance and 30" min. clear width. Ensure accessible work surfaces are well integrated with class seating plans.	1	350	\$350
67	3rd Grade Classroom (Alternative)	3	301	Operable Parts	Other

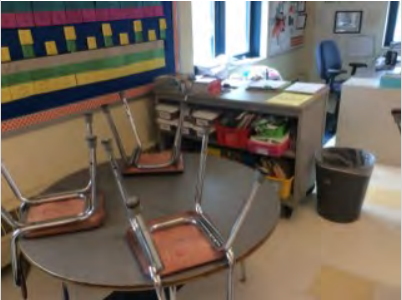
Clear floor space is not provided	-	Rearrange furniture to provide a 30" min. by 48" min. clear floor space at the material shelf.	1	Labor	\$0
Additional Access												
68	3rd Grade Classroom (Alternative)	3	301	Sinks for Children's Use	Classroom

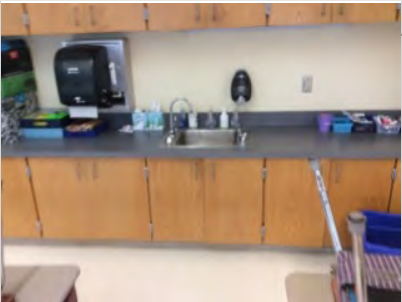
Knee or toe clearance not provided	-	Provide at least one sink with 25" knee and toe clearance positioned for a forward approach.	1	843	\$843

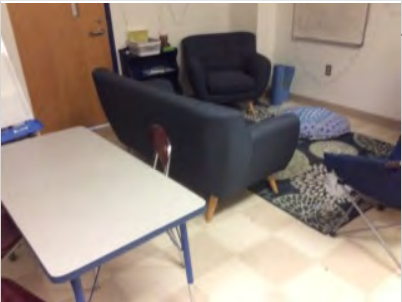
Access to Goods and Services												
69	Counseling Office	3	303	Doors, Doorways, & Gates	Office

Maneuvering clearance(s) not provided	-	Reconfigure furniture to provide maneuvering clearance at the door. The door should have 60" clear in front of it with 18" clear on the latch pull side of the door.	1	Labor	\$0
70	Counseling Office	3	303	Interior Access Route	N/A

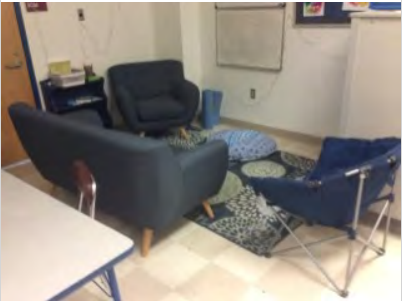
Route < 36" wide Surface not stable, firm, and slip-resistant	- -	Reconfigure furniture to provide a continuous 36" wide circulation path. Secure the mat.	1	Labor	\$0

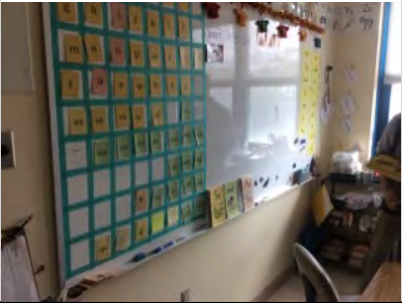
Clear floor space is not provided	-	Provide a 30" min. by 48" min. clear floor space at the white board.	1	Labor	\$0
Access to Goods and Services												
73	Counseling Office	3	303D	Signage	Designation

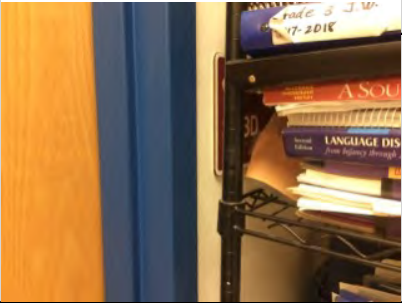
Sign lacks clear floor space	-	Relocate furniture to provide 18" x 18" min. clear floor space centered on the sign.	1	Labor	\$0
Access to Goods and Services												
74	Classroom	3	306	Operable Parts	Other

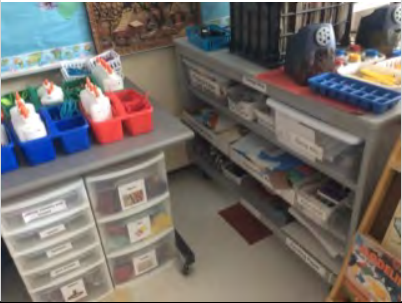
Clear floor space is not provided	-	Reconfigure space to provide a 30" min. by 48" min. clear floor space at the material shelf.	1	Labor	\$0

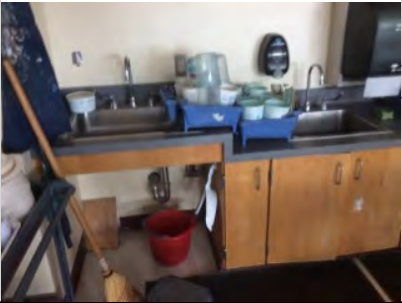
Rim or counter at sink > 30" Exposed plumbing underneath Knee or toe clearance not provided	34" - -	Relocate sink with the front of the rim or counter no higher than 30". Insulate or otherwise configure pipes to prevent contact at sink. Remove bucket underneath sink.	1	1593	\$1593
Toilet Rooms for Children												
77	Girls' Third Floor Toilet Room	3	306	Toilet Compartment	Accessible Compartment

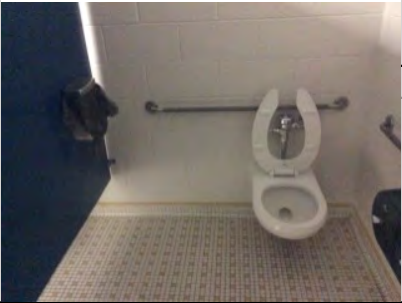
Side or rear grab bar < 25" or > 27" high (Ages 9 - 12) Centerline < 15" or > 18" (Ages 9 - 12) Non-compliant toilet paper dispenser	30" 19" -	Relocate grab bars to 25"- 27" above the floor. Relocate toilet so that the centerline is between 15" and 18" from the side wall. Replace toilet paper dispenser with one that allows continuous paper flow.	1	1895	\$1895

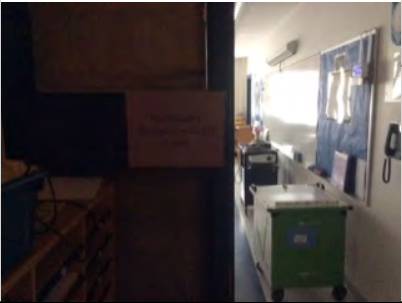
Access to Goods and Services												
78	4th Grade Classroom (Alternative)	3	318	Signage	Designation

Raised characters not provided Braille not provided	- -	Provide text with raised characters duplicated in braille.	1	116	\$116

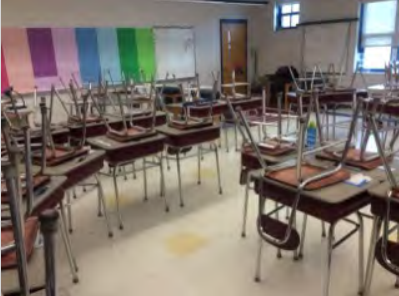
ID	Location	Floor	Room	Element	Type	Photo	Issues	Current Measure	Recommendations	Quantity	Price	Cost Estimation
79	4th Grade Classroom (Alternative)	3	318	Dining or Work Surfaces	Work Surface

At least one or 5% accessible tables not provided	-	Provide at least one (1) accessible desk with 24" min. knee clearance and 30" min. clear width. Ensure accessible work surfaces are well integrated with class seating plans.	1	350	\$350
80	4th Grade Classroom (Alternative)	3	318	Interior Access Route	N/A

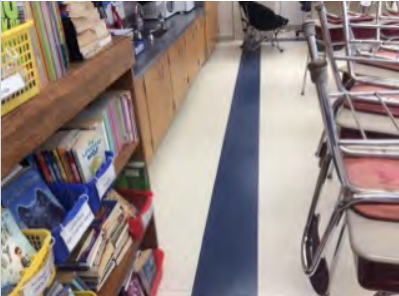
Route < 36" wide	18"	Reconfigure room to ensure that there is a clear width of 36" min. in the circulation path.	1	Labor	\$0
81	4th Grade Classroom (Alternative)	3	318	Interior Access Route	N/A

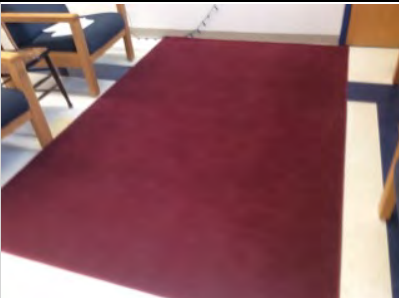
Surface not stable, firm, and slip-resistant	-	Secure the mat.	1	Labor	\$0
82	4th Grade Classroom (Alternative)	3	318	Operable Parts	Other

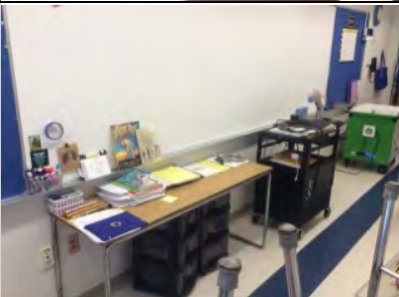
Clear floor space is not provided	-	Provide a 30" min. by 48" min. clear floor space at the white board.	1	Labor	\$0

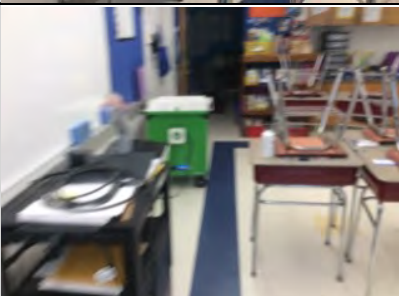
83	4th Grade Classroom (Alternative)	3	318	Interior Access Route	N/A

Route < 36" wide	16"	Reconfigure room to ensure that there is a clear width of 36" min. in the circulation path.	1	Labor	\$0

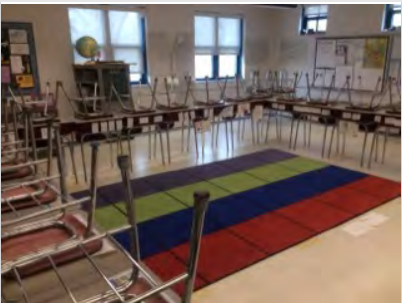
At least one or 5% accessible tables not provided	-	Provide at least one (1) accessible desk with 24" min. knee clearance and 30" min. clear width. Ensure accessible work surfaces are well integrated with class seating plans.	1	350	\$350
86	5th Grade Classroom (Alternative)	3	322	Interior Access Route	N/A

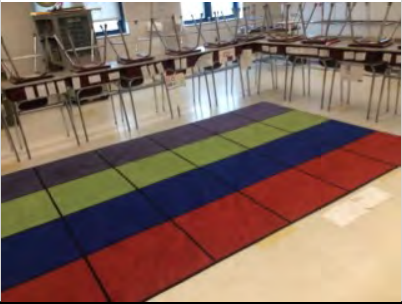
Surface not stable, firm, and slip-resistant	-	Secure the mat.	1	Labor	\$0
Additional Access

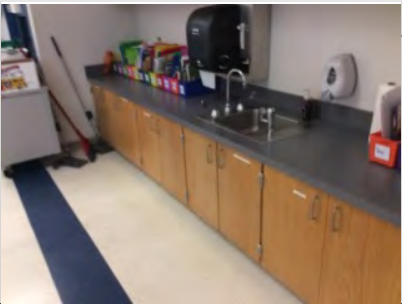
87	5th Grade Classroom (Alternative)	3	322	Sinks for Children's Use	Classroom

Knee or toe clearance not provided	-	Provide at least one sink with 25" knee and toe clearance positioned for a forward approach.	1	843	\$843

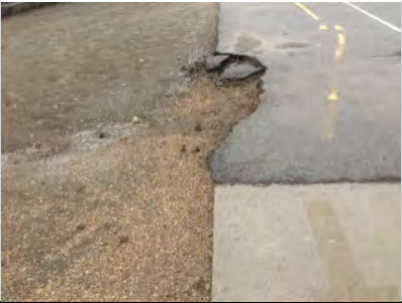
ID	Location	Floor	Room	Element	Type	Photo	Issues	Current Measure	Recommendations	Quantity	Price	Cost Estimation
Approach and Entrance												
88	Basketball Court	Ext.		Exterior Access Route	Walkway

Level changes > 1/4"	2.5"	Repair surface. (Cost estimate for 4 ft. x 5 ft. asphalt area.)	1	173	\$173
Play and Sport Areas												
89	Kindergarten Playground	Ext.		Play Areas	N/A

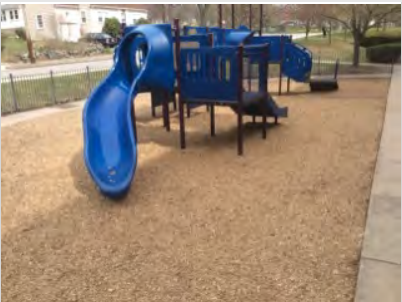
Surface not stable, firm, and slip-resistant	-	Provide a 60" wide min. impact-attenuating rubberized surface path to all play components. (Cost estimate based on installation of 137 linear ft. of rubberized surface.)	1	9590	\$9590
Approach and Entrance												
90	Parking Lot	Ext.		Off-Street Parking Lot or Garage	Visitor

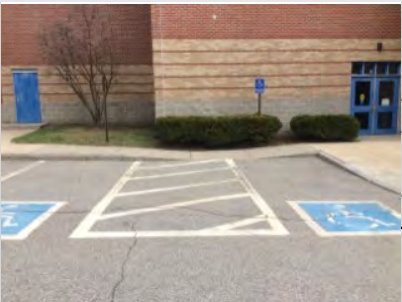
Total # of parking Total # of designated accessible parking spaces Total # of designated van accessible spaces Vehicle space < 96" wide at car space Access aisle < 96" wide at van space Sign not provided Sign does not have the designation "Van Accessible"	40 2 0 86" 82" - -	Convert at least one (1) accessible space into a van-accessible space. Provide a car-accessible space that is at least 96" wide. Provide a marked access aisle that is at least 96" wide at van-accessible space. Provide a sign at each space. Add the designation "Van Accessible" to the sign located at the van-accessible space.	1	950	\$950

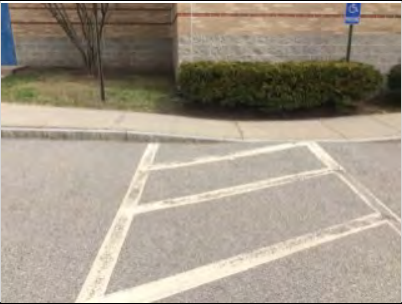
91	Parking Lot	Ext.		Off-Street Parking Lot or Garage	Visitor

Access aisle does not adjoin an accessible route		When restriping lot per previous record (#89) , ensure that the access aisle lines up with the curb ramp that is provided. Per 521 CMR 23.5, Where sidewalks are provided at accessible parking spaces, a curb cut shall be installed at the access aisle at each accessible space or pair of spaces.	1	-	\$0
92	Parking Lot	Ext.		Curb Ramp	N/A

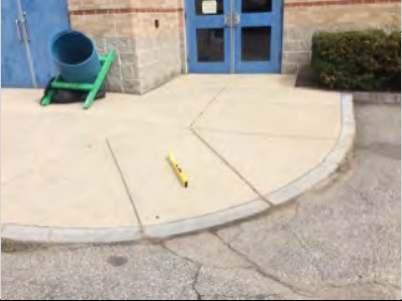
Running slope > 1:12 (8.33%)	11.2%	Reduce running slope to be no steeper than 1:12 (8.33%).	1	2800	\$2800

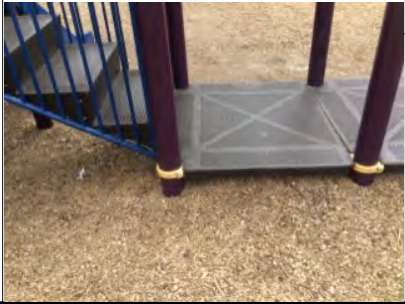
96	Streetside Playground	Ext.		Play Areas	N/A

No compliant transfer system	-	Alteration might be technically infeasible.	1	-	\$0

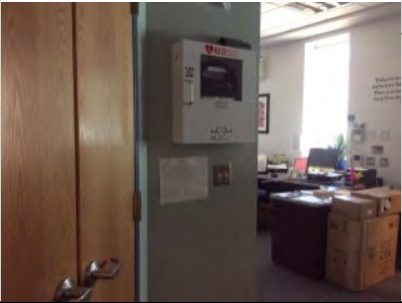
Reach < 15" or > 48"(forward/side approach)	63"	Relocate AED device so that controls are between 15"- 48" above finished floor.	1	128	\$128
Approach and Entrance												
3	Exit 10	1		Emergency Exit	N/A

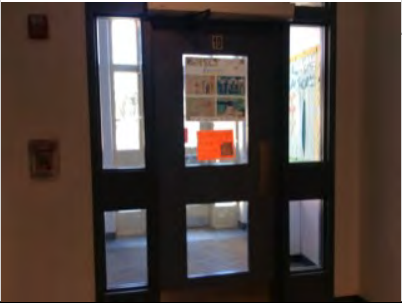
Automatic door opener not operable	-	Repair or replace the door opener.	1	1350	\$1350
Access to Goods and Services												
4	Exit 10	1		Means of Egress	N/A

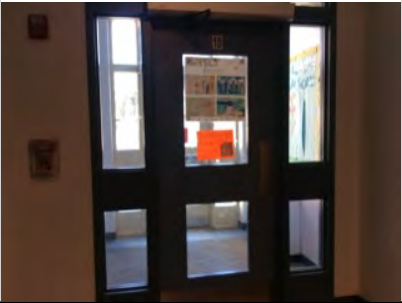
Illuminated exit sign not provided Tactile exit sign not provided	- -	Provide illuminated exit signs with the International Symbol of Accessibility at accessible exits. Provide tactile exit signs with raised characters and braille at exit doors. Mount signs between 48"- 60" above finished floor located on the latch side of the door.	2	116	\$232

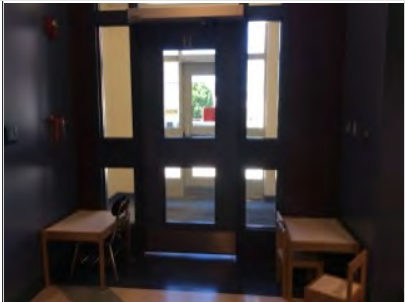
Illuminated exit sign not provided Tactile exit sign not provided	-	Provide illuminated exit signs with the International Symbol of Accessibility at accessible exits. Provide tactile exit signs with raised characters and braille at exit doors. Mount signs between 48"- 60" above finished floor located on the latch side of the door.	2	116	\$232
Access to Goods and Services												
7	Exit 7 in Cafetorium	1		Means of Egress	N/A

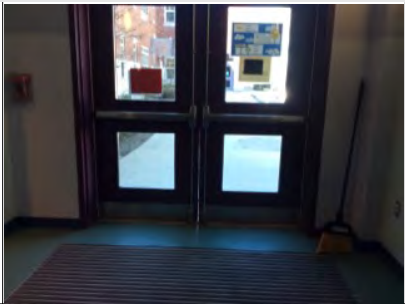
Illuminated exit sign not provided Tactile exit sign not provided	-	Provide illuminated exit signs with the International Symbol of Accessibility at accessible exits. Provide tactile exit signs with raised characters and braille at exit doors. Mount signs between 48"- 60" above finished floor located on the latch side of the door.	2	116	\$232

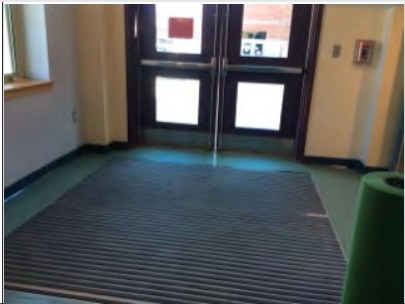
Access to Goods and Services												
8	Exit in Stair 2	1		Means of Egress	N/A

Illuminated exit sign not provided Tactile exit sign not provided	-	Provide illuminated exit signs with the International Symbol of Accessibility at accessible exits. Provide tactile exit signs with raised characters and braille at exit doors. Mount signs between 48"- 60" above finished floor located on the latch side of the door.	2	116	\$232

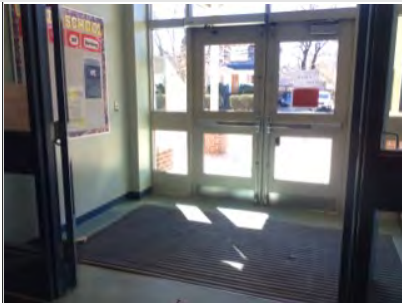
Illuminated exit sign not provided Tactile exit sign not provided	-	Provide illuminated exit signs with the International Symbol of Accessibility at accessible exits. Provide tactile exit signs with raised characters and braille at exit doors. Mount signs between 48"- 60" above finished floor located on the latch side of the door.	2	116	\$232
11	Main Entrance	1		Doors, Doorways, & Gates	Circulation

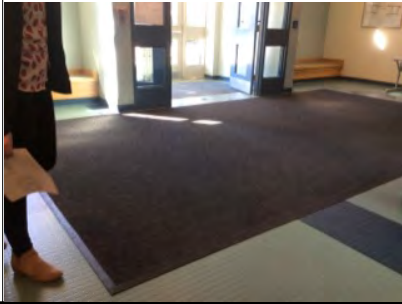
Mat not securely attached	-	Securely attach mat.	1	Labor	\$0
Access to Goods and Services												
12	Conference Room in Administration Office	1	106	Doors, Doorways, & Gates	Meeting Room

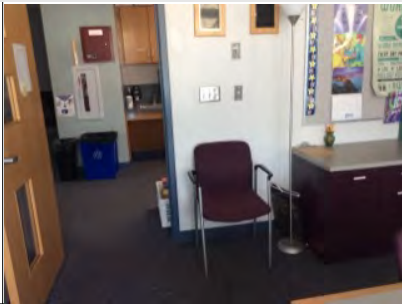
Maneuvering clearance(s) not provided	-	Relocate the chair to ensure there is 18" clear on the latch pull side of the door.	1	Labor	\$0

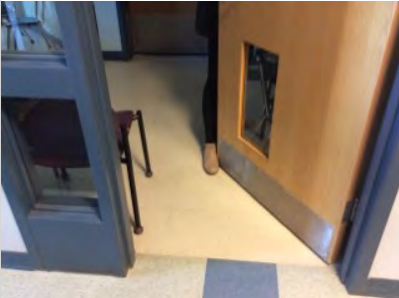
Clear width at door < 32"	-	Remove furniture at the interior of the door.	1	Labor	\$0
14	Nurse's Office	1	109	Doors, Doorways, & Gates	N/A

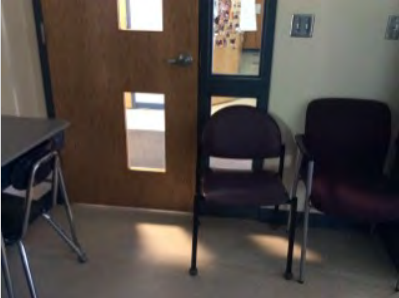
Maneuvering clearance(s) not provided	-	Relocate the chair to ensure there is 18" clear on the latch pull side of the door.	1	Labor	\$0
15	Nurse's Office	1	109	Doors, Doorways, & Gates	Circulation

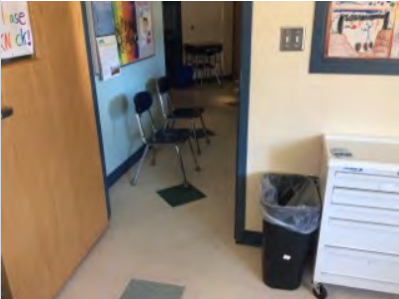
Maneuvering clearance(s) not provided	-	Relocate the furniture to ensure there is 18" clear on the latch pull side of the door.	1	Labor	\$0
Additional Access												
16	Nurse's Office	1	109	Sink	N/A

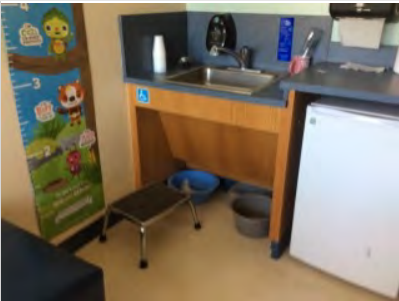
Clear floor space not provided at sink	-	Provide a 30" by 48" clear floor space positioned for a forward approach. Ensure the area beneath the sink is clear of obstructions.	1	-	\$0

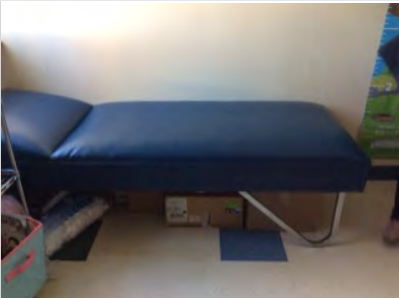
Best Practice												
17	Nurse's Office	1	109	N/A	N/A

Best Practice: Consider providing an adjustable height bed.	1	-	\$0

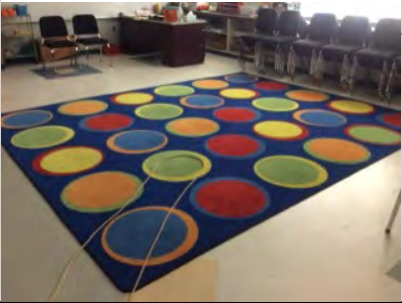
Mat not securely attached	-	Securely attach mat.	1	Labor	\$0
Additional Access												
20	Music Room	1	112	Sink	Classroom

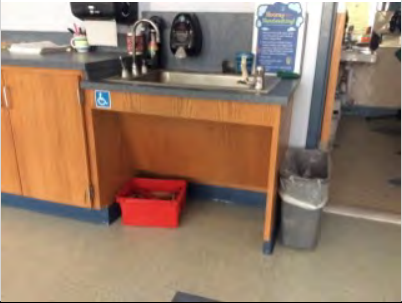
Clear floor space not provided at sink Toe and knee clearances not provided	- 24"	Relocate bin to provide a 30" by 48" clear floor space positioned for a forward approach. Ensure there is a 25" knee clearance positioned for a forward approach.	1	843	\$843
Access to Goods and Services												
21	Classrooms Throughout School	1	114, 132, 157, 206, 209, 212, 213, 223, 224, 227	Interior Access Route	N/A

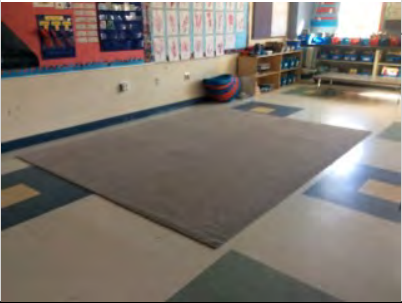
Mat not securely attached	-	Securely attach mats in classrooms throughout the school.	12	Labor	\$0

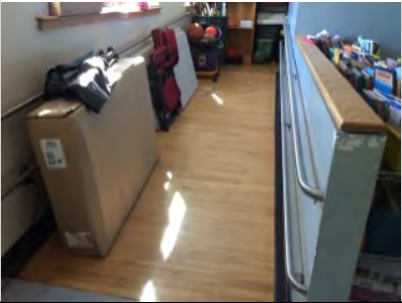
Not maintained in operable working condition	-	Relocate items that are stored on the ramp.	1	Labor	\$0
Access to Goods and Services												
24	Cafetorium, Stage	1	117	Interior Access Route	N/A

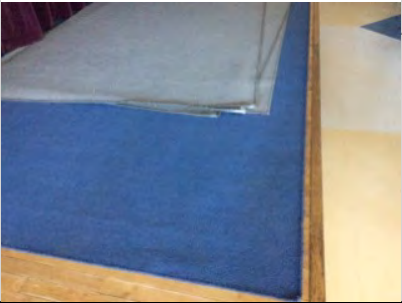
Mat not securely attached	-	Securely attach mat.	1	Labor	\$0
Access to Goods and Services												
25	Exit 9 in Cafetorium	1	117	Means of Egress	N/A

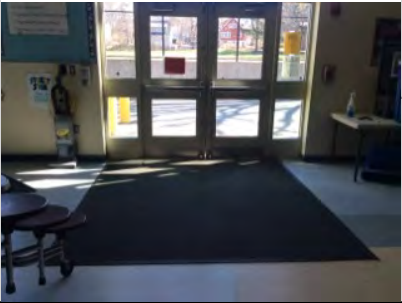
Illuminated exit sign not provided Tactile exit sign not provided Mat not securely attached	-	Provide illuminated exit signs with the International Symbol of Accessibility at accessible exits. Provide tactile exit signs with raised characters and braille at exit doors. Mount signs between 48"- 60" above finished floor located on the latch side of the door. Securely attach mat.	2	116	\$232

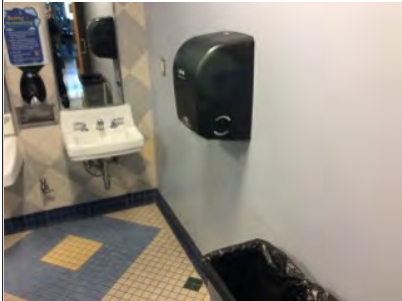
Dispenser acts as a protruding object	9"	Relocate paper towel dispensers out of the circulation path.	8	353	\$2824
Access to Goods and Services												
27	Classroom	1	133	Interior Access Route	N/A

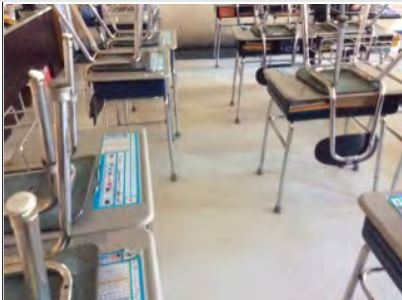
Route < 36" wide	18"	Ensure that a clear width of 36" min. is maintained at the accessible route. Relocate furniture.	1	Labor	\$0
Access to Goods and Services												
28	Exit 4 in Kindergarten Cubbies Area	1	142	Means of Egress	N/A

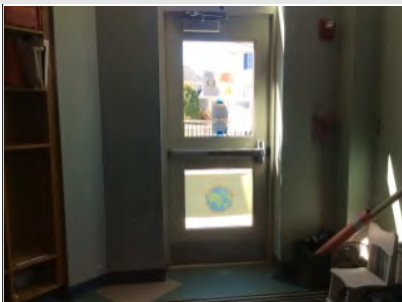
Illuminated exit sign not provided Tactile exit sign not provided	- -	Provide illuminated exit signs with the International Symbol of Accessibility at accessible exits. Provide tactile exit signs with raised characters and braille at exit doors. Mount signs between 48"- 60" above finished floor located on the latch side of the door.	2	116	\$232

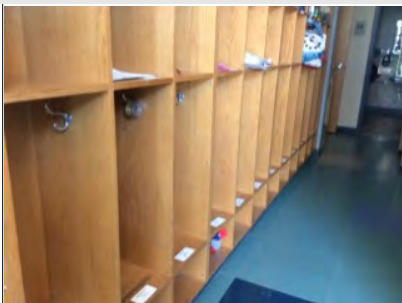
Reach < 18" or > 40" (Ages 5 - 8)	45"	Storage is provided for 48 children. Five percent of storage (or three storage areas) should be accessible for children in Kindergarten. Relocate so the operable part is between 18" and 40" above finished floor.	3	256	\$768

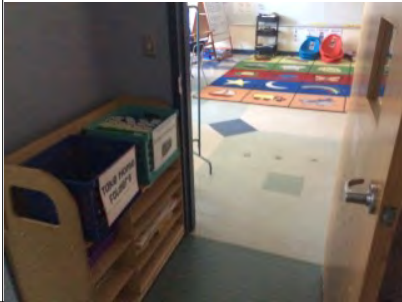
Maneuvering clearance(s) not provided	-	Remove the furniture to ensure that there is 18" on the latch pull side of the door.	1	Labor	\$0
Toilet Rooms for Children												
31	Kindergarten Toilet Rooms	1	142	Single-User Toilet	N/A

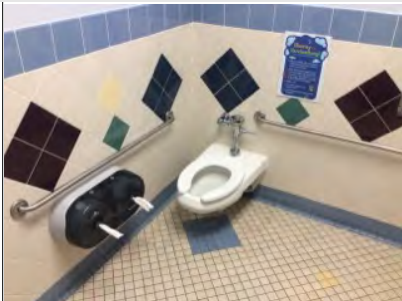
Non-compliant toilet paper dispenser	-	Replace toilet paper dispenser if it does not allow continuous paper flow.	1	453	\$453
32	Kindergarten Toilet Rooms	1	142	Dispensers	Paper Towel Dispenser

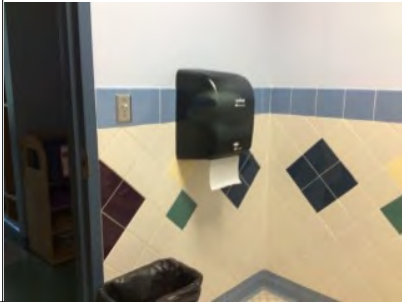
Dispenser acts as a protruding object	-	Relocate paper towel dispensers out of the circulation path.	2	353	\$706
Access to Goods and Services												
33	Kindergarten Classrooms	1	142 147	Interior Access Route	N/A

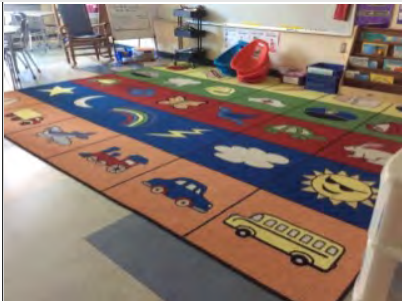
Mat not securely attached	-	Securely attach mat.	2	Labor	\$0

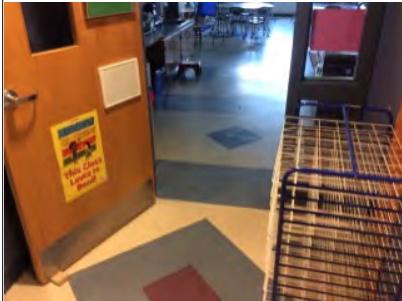
Maneuvering clearance(s) not provided	-	Remove the obstructions at alcoves of classroom entrances. Relocate the furniture to ensure there is 18" clear on the latch pull side of the door.	10	Labor	\$0
Access to Goods and Services												
35	Exit 3,in Kindergarten Cubbies Area	1	149	Means of Egress	N/A

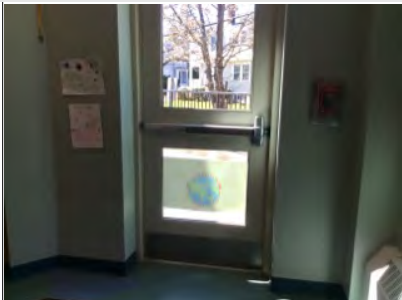
Illuminated exit sign not provided Tactile exit sign not provided	- -	Provide illuminated exit signs with the International Symbol of Accessibility at accessible exits. Provide tactile exit signs with raised characters and braille at exit doors. Mount signs between 48"- 60" above finished floor located on the latch side of the door.	2	116	\$232

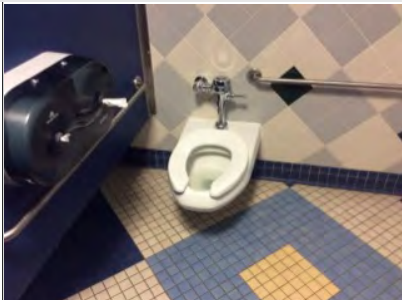
Non-compliant toilet paper dispenser Coat hook not within reach range	- 63.25"	Relocate toilet paper dispenser so it is not mounted above the grab bar. Replace toilet paper dispenser if it does not allow continuous paper flow. Lower hook so that it is no higher than 40" for children ages 5-8.	4	528	\$2112
Toilet Rooms for Children												
37	Girls' Toilet Rooms Near Rooms 131, 157, 212, and 227	1 2		Toilet Compartment	Accessible Compartment

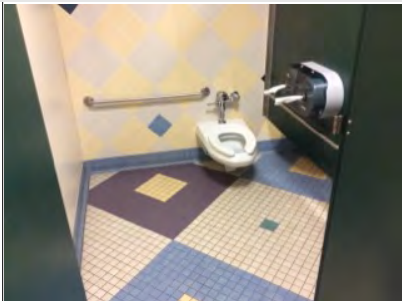
Door with malfunctioning self-closing hinge Non-compliant toilet paper dispenser Coat hook not within reach range	- - 64"	Repair self-closing hinge. Relocate toilet paper dispenser so it is not mounted above the grab bar. Replace toilet paper dispenser if it does not allow continuous paper flow. Lower hook so that it is no higher than 40" for children ages 5-8.	4	Labor 528	\$2112

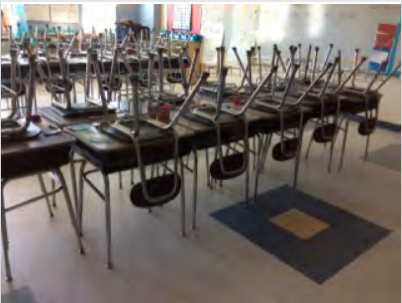
At least one or 5% accessible tables not provided	19" wide	Ensure that at least one work surface in one classroom of each grade is accessible and integrated into the classroom layout.	6	350	\$2100
Access to Goods and Services												
40	Library	2	202	Signage	Designation

Work Surfaces
The traditional desks found in most classrooms lack the knee clearance and width to be considered an accessible work surface. Some rooms do have additional seating, but they are not incorporated into the classroom layout. IHCD strongly recommends providing at least one classroom per grade an

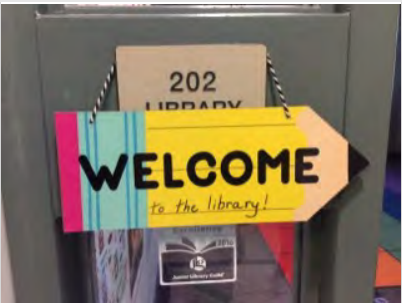
Braille misplaced	-	Ensure paper sign is relocated so that the existing sign with braille and raised characters are fully visible and usable.	1	Labor	\$0

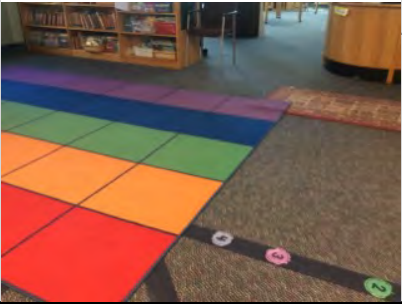
41	Library	2	202	Interior Access Route	N/A

Mat not securely attached	-	Securely attach mat.	1	Labor	\$0

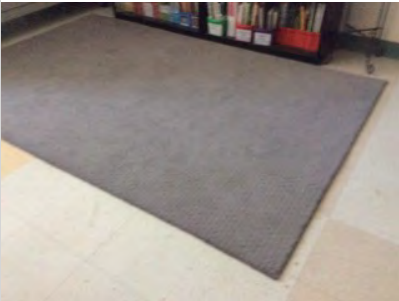
Mat not securely attached	-	Securely attach mat.	1	Labor	\$0
43	Art Studio	2	211	Interior Access Route	N/A

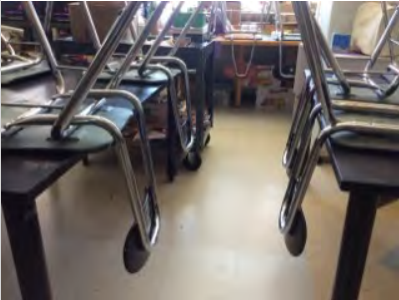
Route < 36" wide	22"	Ensure that a clear width of 36" min. is maintained at the accessible route. Relocate furniture.	1	Labor	\$0
44	Art Studio	2	211	Interior Access Route	N/A

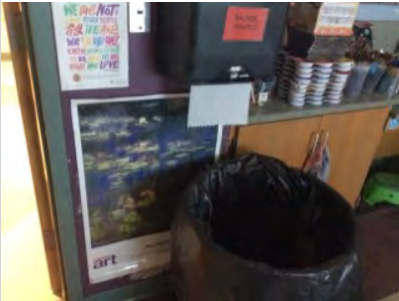
Obstructed by protruding objects	-	Relocate dispenser out of the circulation path.	1	128	\$128
Additional Access												
45	Art Studio	2	211	Sink	Classroom

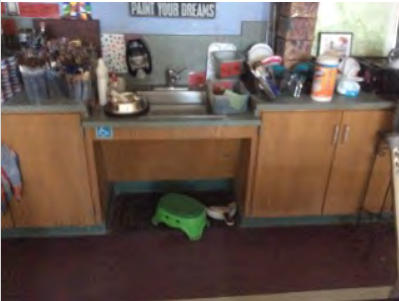
Clear floor space not provided at sink	-	Provide a 30" by 48" clear floor space positioned for a forward approach. Ensure the area beneath the sink is clear of obstructions.	1	-	\$0
Access to Goods and Services												
46	Art Studio, Route to 3D Printers	2	211	Interior Access Route	N/A

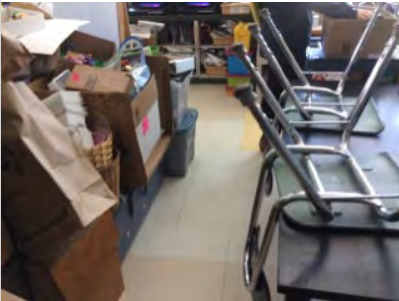
Route < 36" wide	25"	Ensure that a clear width of 36" min. is maintained at the accessible route. Relocate furniture.	1	Labor	\$0

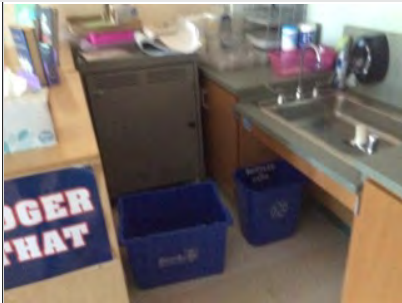
Route < 36" wide	28"	Ensure that a clear width of 36" min. is maintained at the accessible route and 48" at the sink. Relocate furniture.	1	Labor	\$0
Access to Goods and Services												
49	Learning Center	2	222	Signage	Designation

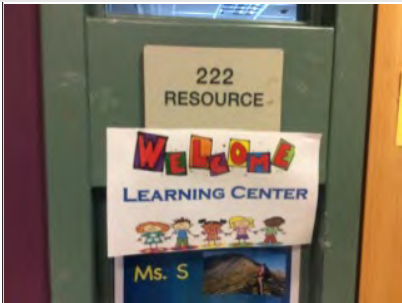
Raised characters not provided Braille not provided	- -	Provide text with raised characters duplicated in braille that match the long term use of the space.	1	116	\$116
Access to Goods and Services												
50	Learning Center	2	223	Interior Access Route	N/A

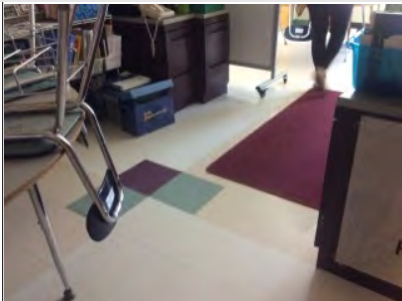
Route < 36" wide	33" -	Ensure that a clear width of 36" min. is maintained at the accessible route. Relocate furniture.	1	Labor	\$0

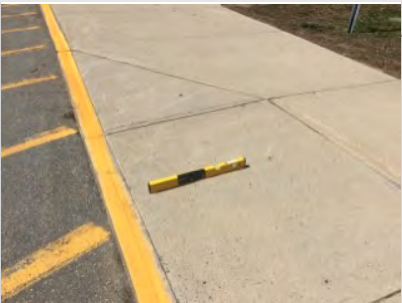
Running slope > 1:12 (8.33%)	9.1%	Reduce running slope to be no steeper than 1:12 (8.33%).	1	2800	\$2800
Approach and Entrance												
53	Parking Lot	Ext.		Exterior Access Route	Exterior

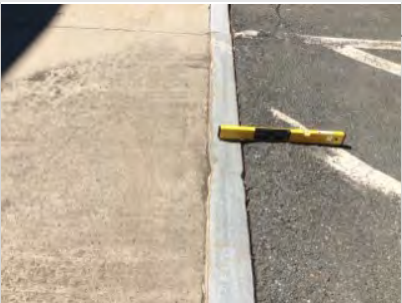
Running slope > 1:20 (5%) Level changes > 1/4"	6.9% 1.5"	Reduce running slope to be no steeper than 1:20 (5%). Alter change in level to be 1/4" high max. (Cost based on 8' wide 3' deep asphalt area.)	1	208	\$208

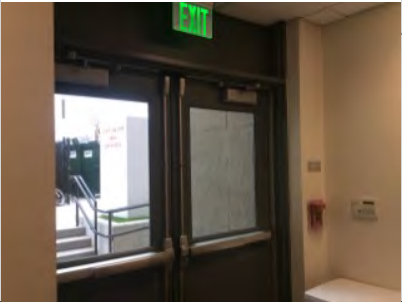
ID	Location	Floor	Room	Element	Type	Photo	Issues	Current Measure	Recommendations	Quantity	Price	Cost Estimation
Approach and Entrance												
1	Exit 11, Near Stair 1	1		Emergency Exit	N/A

International Symbol of Acc. not provided		Provide an illuminated International Symbol of Accessibility at the accessible exits.	1	116	\$116
Access to Goods and Services												
2	Exit 11, Near Stair 1	1		Signage	Egress

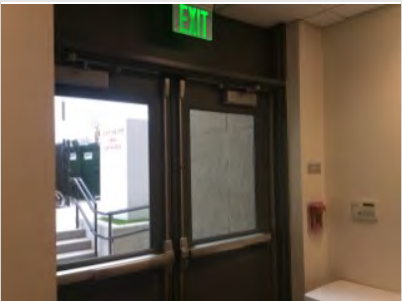
Lack of clear floor space at tactile sign		Remove table and chair so that signs containing tactile characters are located so that a clear floor space of 18" min. by 18" min., centered on the tactile characters, is provided.	1	Labor	\$0
3	Exit 11, Near Stair 1	1		Doors, Doorways, & Gates	Emergency Egress

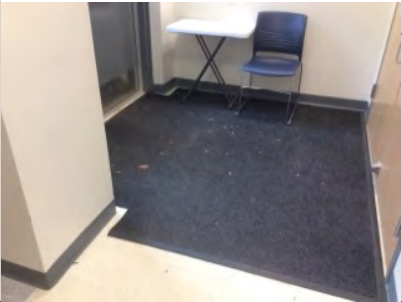
Mat not securely attached	-	Secure the mat.	1	Labor	\$0
Approach and Entrance												
4	Exit 12 in Cafeteria	1		Emergency Exit	N/A

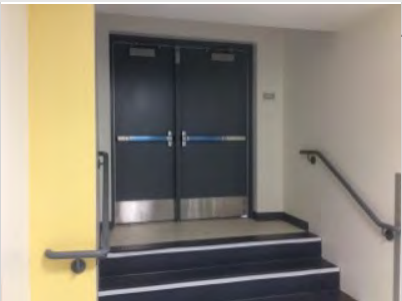
Directional sign to accessible emergency exit not provided	-	Provide a directional sign indicating the location of the nearest emergency exit.	1	116	\$116

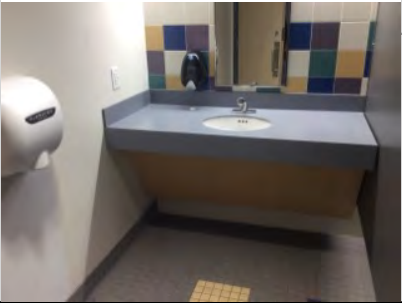
Dispenser acts as a protruding object	36"	Relocate the hand dryer out of the circulation path.	1	353	\$353
Access to Goods and Services												
7	Main Entrance, Exit 1	1		Doors, Doorways, & Gates	N/A

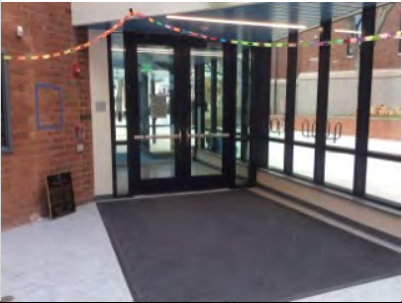
Mat not securely attached	-	Secure the mat.	1	Labor	\$0
Additional Access												
8	Near Cafeteria	1		Drinking Fountains	Hi-Lo

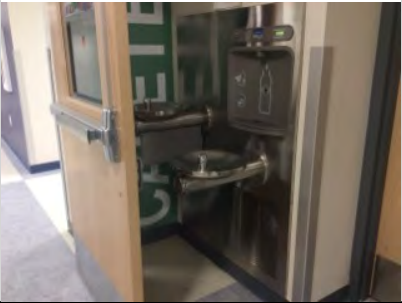
Fountain not on accessible route	-	When cafeteria doors are propped open, drinking fountains lack required clear floor space. In addition, there is a safety issue: people opening these doors may bump into people who are using the drinking fountains. If possible make the other leaf the active leaf or relocate the drinking fountains to another location.	1	Labor	\$0

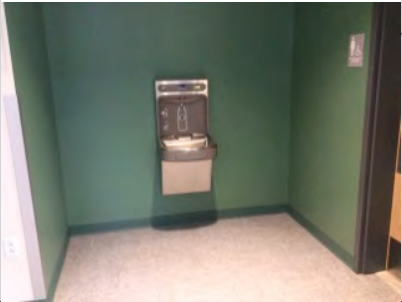
ID	Location	Floor	Room	Element	Type	Photo	Issues	Current Measure	Recommendations	Quantity	Price	Cost Estimation
Additional Access												
9	Near Main Office	1		Drinking Fountains	Low

No drinking fountain provided for standing users	-	Provide an additional drinking fountain for standing users.	1	2014	\$2014
Access to Goods and Services												
10	Nurse's Office	1		Doors, Doorways, & Gates	Other

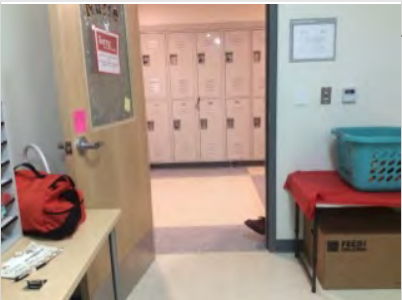
Maneuvering clearance(s) not provided	-	Remove the table to provide 18" clear on the latch pull side of the door.	1	Labor	\$0
Access to Goods and Services												
11	Stair 1	1		Interior Access Route	N/A

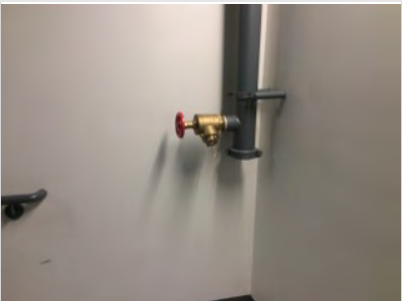
Obstructed by protruding objects	45"	Provide a cane-detectable barrier at the valve.	1	153	\$153
Access to Goods and Services												
12	Stair 1, Near Cafeteria	1		Doors, Doorways, & Gates	Circulation
